Pickings from extractions

The AGB Portable EDM Model 2

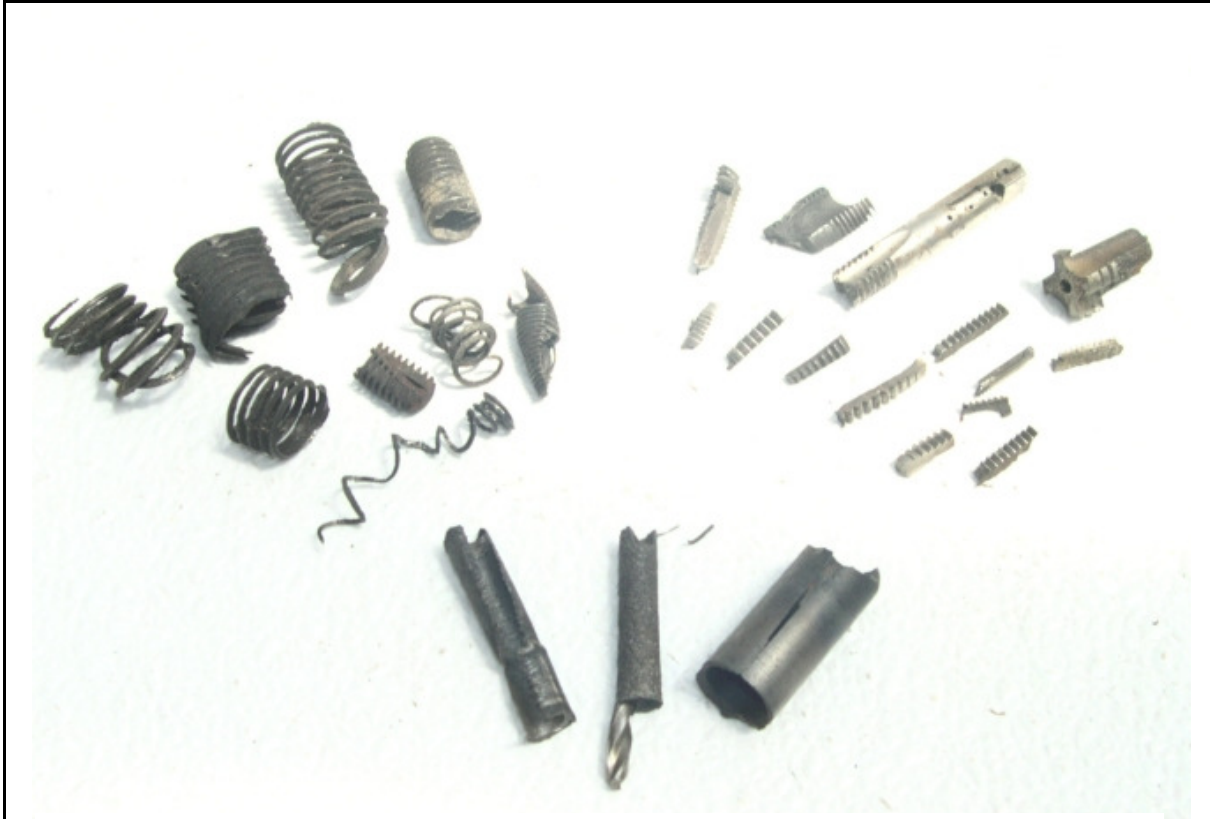
Upper left are coils of stud threads after picking out. They don't usually come out in one piece as this might imply.

Upper right are tap remnants from picking. This is very typical when removing taps.

Lower section right and left are solid pins or dowels which were edm'd to leave a thin wall and then forced out. The center object is the core of a broken stud which someone had attempted to drill out and broke the drill. The EDM electrode is tubing and burns a donut hole as in a hole saw and this is the core that is left after the hole is edm'd. Drill is visible at bottom.
