Miscellaneous broken stud, pin, tap removal examples.

The AGB Portable EDM Model 2

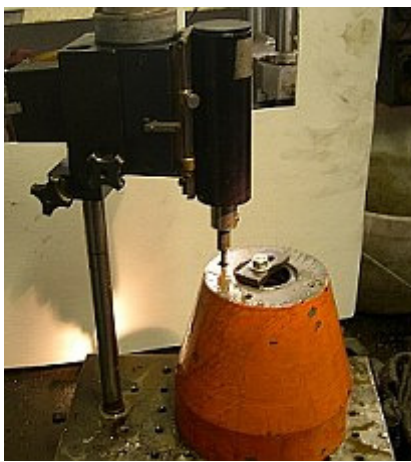
Job: Remove 5/16-18 Broken tap from casting.
Electrode = graphite .185 OD x .065" ID

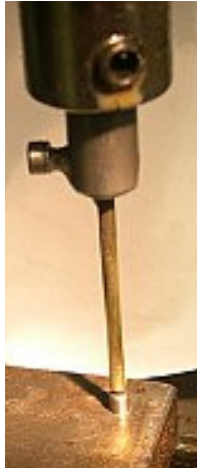
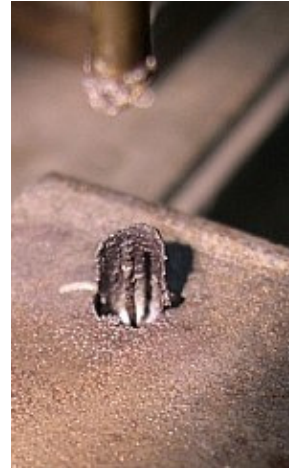
Remove 3/32 dowel pin.
Electrode .072" Brass tubing
Time = 3 minutes.
Last photo shows sleeve remaining to be picked out.

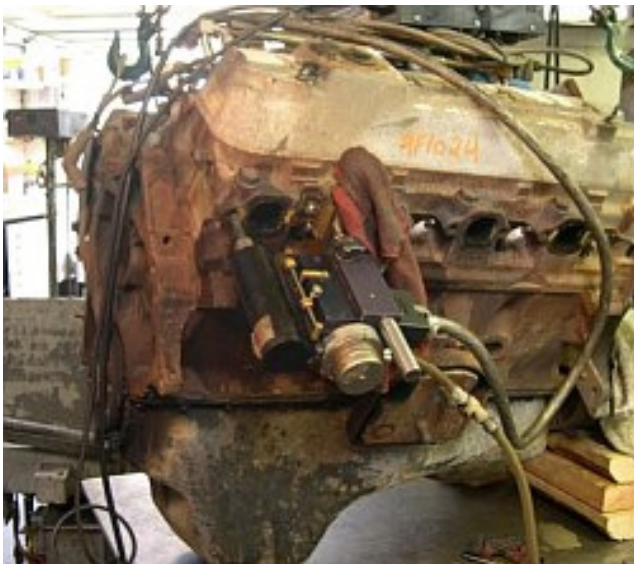
Setup on exhaust stud in V8 Motor
