Miscellaneous broken stud, pin, tap removal examples.

The AGB Portable EDM Model 2

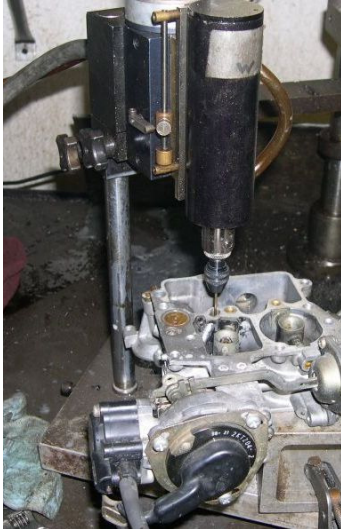
Carburetor with small needle valve screw to be removed. Electrode: .062" Brass tubing. Time: 2 min-

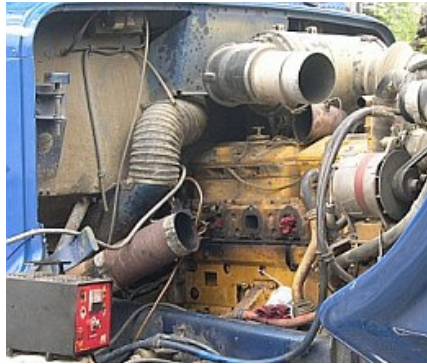
Shows EDM machine setup on diesel truck motor to remove an exhaust manifold stud broken off in cylinder head.

In left photo machine is not set up yet In right photo electrode is at bottom right after burning hole through broken stud. In this case there was a broken easy-out broken in the stud.

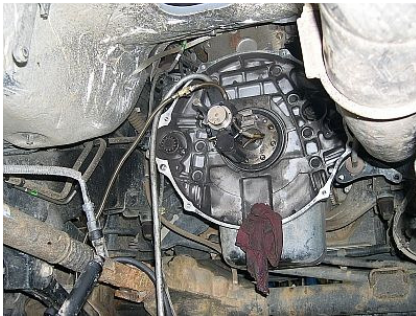
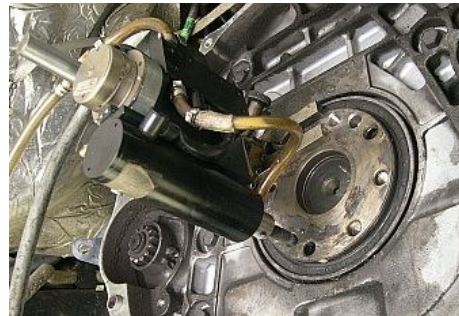
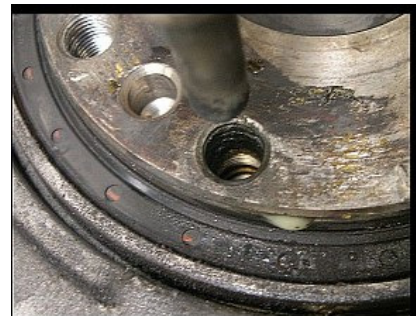
Job: Broken stud in crankshaft end plate. Engine is in vehicle and on a lift with transmission and flywheel removed (photo 1). Machine is set up using a neighbor threaded hole in crankshaft (photo 2). Hole after EDM work and before picking out remaining thread sleeve Electrode: Graphite tube 10 mm stud 20 mm deep Time: 12 minutes. Last photo shows stud removed and ready to pick out remainder of thread sleeve .

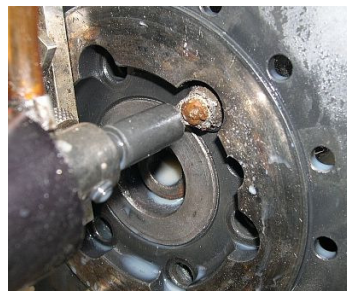
Job: EDM stripped head of ring gear bolt. Then unscrew bolt by hand. Again, working under lift. Rear of engine shown. Electrode Graphite Tube 5/8 OD x 3/8 ID Time = 6 minutes
